**TERRACE LAKE DAM  
JACKSON COUNTY, MISSOURI  
MO 20167**

## **PHASE 1 INSPECTION REPORT NATIONAL DAM SAFETY PROGRAM**

**AUGUST 1978**

PHASE I INSPECTION REPORT

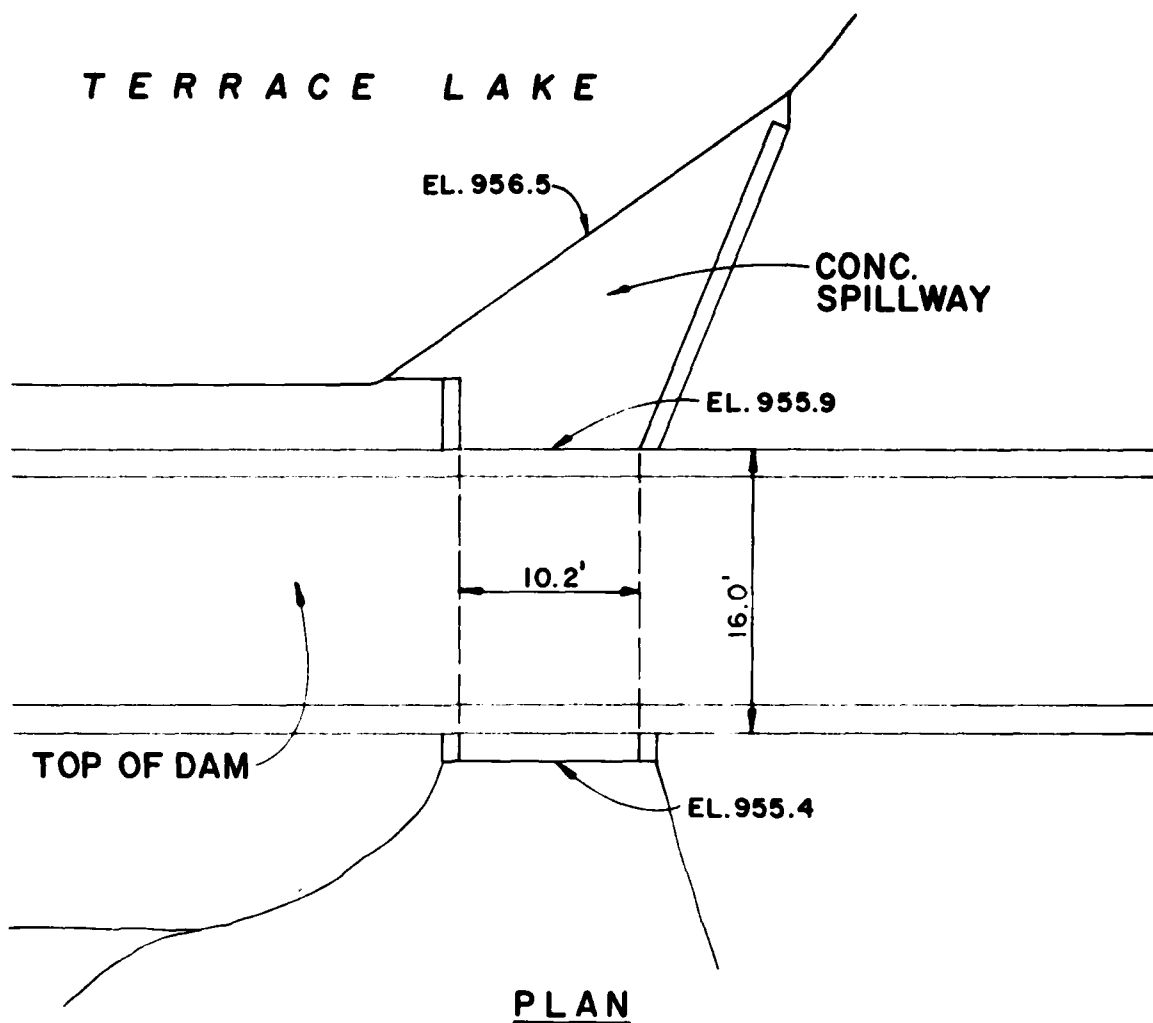
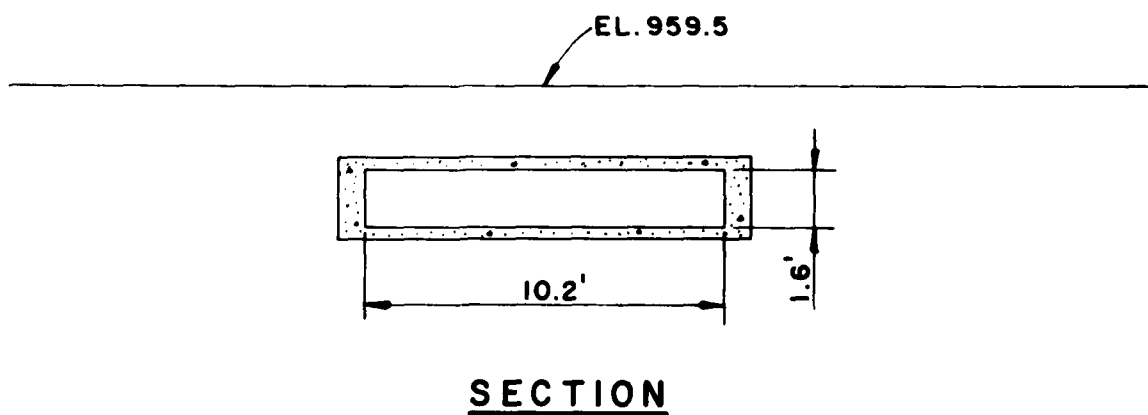
TERRACE LAKE  
SPILLWAY

c. Appurtenant Structures. The spillway is a 10.2 by 1.6 feet box culvert with a concrete approach apron beginning 10 feet upstream of the spillway. The spillway appeared in good condition other than some minor spalling. The spillway discharges into a broken limestone channel which is severely overgrown with weeds and small trees. Erosion was observed behind the left spillway training wall, but did not appear serious. Seepage of less than 5 gpm was observed in the discharge channel about 25 feet downstream from the axis of the dam.

(1) Concrete spillway and the spillway discharge channel are in good condition. Heavy growth of weeds and small timber in the discharge channel was observed. Because there are no training walls along the discharge channel, flows that exceed the channel capacity would overflow onto the downstream embankment slope and erode the embankment material resulting in a serious potential of failure. The obstructions in the channel would magnify this problem.
